Full Report of Service Disruption on 26 February 2017

On 26 February 2017, a power interruption at one mobile switching data center caused service disruption of China Mobile Hong Kong Company Limited (“CMHK”) network partially. This full report provides a description of events that led to the occurrence of service disruption, the remedial actions taken and the improvement measures to be taken.

China Mobile Hong Kong Co. Ltd.

Date: 16-Mar-2017

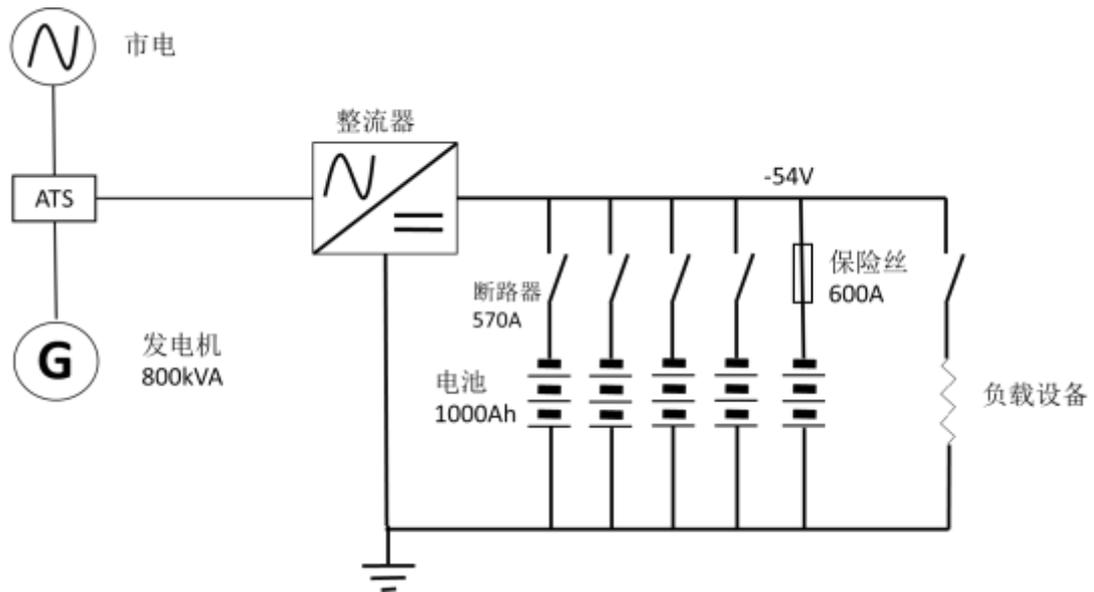
There are 5 banks of backup batteries (@1000AH) installed for the DC power system, which should maintain the power supply for the data center in event of both city power and generator failure. Below shows the connectivity of the DC power system. The DC power system consists of rectifiers (整流器) to convert AC into DC power for telecom network equipment. The current load was about 1900A (DC current) before the incident.

The output of four battery banks are connected each with 570A MCCB, which were all tripped during the incident. One battery bank is connected with a 600A fuse which was not broken. Vendor investigation of root causes was ongoing and not conclusive. Vendor had provided below possible reasons at the moment:

- The 5 battery paths are not resistance matching rendering an unbalance load among them. Some battery path took up current larger than its breaker rating during the load discharging, which resulted in MCCB tripped.
- As all MCCB's of 4 battery banks were tripped, the load current drawn from the remaining battery bank was instantly very high, and make the discharge voltage rapidly dropped below 40V before the fuse burnt out. The function of Low Voltage Disconnection (LVD) was activated to isolate this battery bank.

Further component isolation and physical tests were needed to investigate the root causes further. The recommended immediate actions are reduction of DC power load in the center, addition of two new battery banks, and upgrade of the 570A breaker to 1250A protection fuse per battery bank. This will increase the backup battery capacity, and increase each battery bank's tolerance margin. Battery Discharge tests will then be conducted for all battery banks, and the unbroken 600A fuse will also be isolated for further root cause analysis.
